Golfing atop a landslide

A signature hole is born at Trump National Golf Course

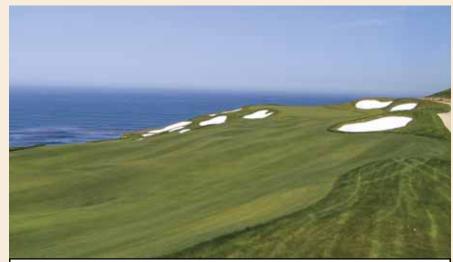
In early June 1999, the 17-acre area of Landslide C re-activated in a single rapid event. The

Photo 1. A landslide took out most of the 18th hole. The rebuild created a signature hole and a signature geotechnical design.

result was the movement of a large "translational block," which occupies the central portion of the slide mass. The slide saw downward movement of almost 10 ft. and horizontal (seaward) translation of about 50 ft. At the base of the slide was an almost horizontal thin layer of bentonite, only 0.12-3 in. thick, that when exposed to water becomes extremely slippery (low friction). The slide mass had a maximum length of 1700 ft., a width over 400 ft. and depth of about 70 ft. The slide took with it most of the 18th hole (fairway and green), bluff edge, pedestrian trails, bikepath, and a portion of a major Los Angeles County Sanitation District sewer line. Many believe that fluid from a leak in this sewer line may have flowed along and saturated the thin layer of betonite, triggering the massive slide.

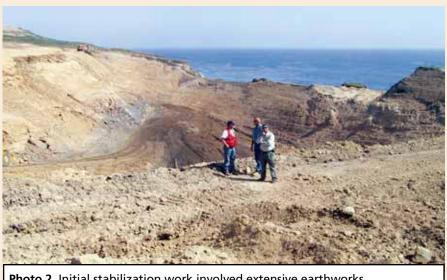
Photo 2. Initial stabilization work involved extensive earthworks.

The first step in repairing the slide area was to stabilize the main slide block with 116 shear pins. Each steel pin was 20 ft. long, 3 ft. wide, and filled with high-density concrete. Shear pins were installed at 25 ft. intervals. Once the shear pins were installed the construction of the MSE wall began by first excavating the slide area (over 1.5 million cubic yards of soil) in sections (6 sections total) to a depth below the failure plane (approximately 100–150 ft.). The 9th and 12th fairways were used for stockpiling the soil from the first section, so that no impact would be made on the sensitive habitat adjacent to the site. Construction of the MSE wall began with placement of the first row of welded wire forms at the bottom of the excavation. Once the first course of forms were placed, the Filterweave 404 was placed up the back of the steel forms, with a 5 ft. long flap of reinforcement draped over the face. Geolon high strength fabric was next placed up to the face of the basket. (The fabric was pre-cut and brought down into the excavation for placement.) On-site fill materials were compacted in place over the reinforcement lengths, and the flap was wrapped back over the top of the soil. The construction process was repeated for each lift (every 18 in.), until the wall reached its full required design height. Total cost: \$61 million.

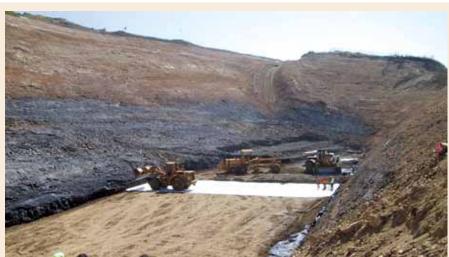
Photo 3. Numerous geotextiles and soil baskets provided vital internal support for the refilled hole.

The actual wall design was performed by Bill Lu at Converse Consultants. The design required interface friction testing for both secondary and primary reinforcement layers for use in global and surficial stability design calculations. Extremely high strength fabrics (over 40,000 lbs/ft. tensile strength) combined with high soil interaction coefficients were essential to the design. Layers of geosynthetic reinforcement were to be placed at approximately 5 ft. vertical intervals with embedment lengths as much as 95 ft. in length (using the higher strength fabrics allowed for larger vertical spacing—resulting in lower installation costs). Mirafi® Geolon® PET600, PET300, PET200 and HS4200 were used as the primary reinforcement to create a massive fabric-wrapped MSE wall buttress (100 ft.+ high). The face of the wall was designed with 18 in. high welded wire forms. The forms were designed to be manufactured with a batter of 4.6° (almost vertical) to match the final design batter of the wall. Mirafi® Filterweave® 404 was designed as secondary reinforcement that would line the interior of the welded forms to contain soil at the face. The face of this massive MSE wall was to abut another reinforced triangular backfill. This second reinforced fill mass abutted existing slide material/native soils of the seaward portion of the landslide, which was left in place to maintain the natural environment, hide the face of the wall, and protect the wall structures from the Pacific Ocean's rage. This composite of soil and high-strength fabric serves as a giant stable soil block that will stop any future movement and protect he rest of the golf course from falling into the ocean.

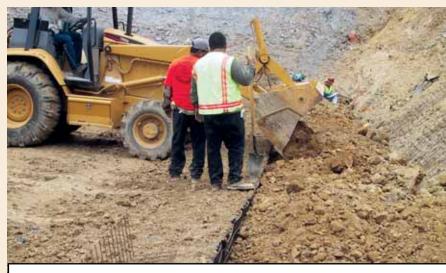
Photo 4. Constructing the geosynthetic-reinforced MSE wall buttress.

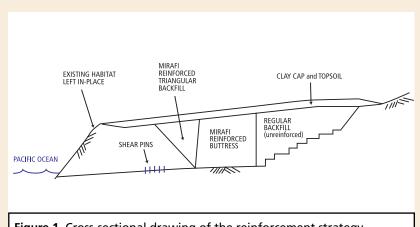
Figure 1. Cross-sectional drawing of the reinforcement strategy.

- 1. Improving the stability of the main slide block with shear pins.
- 2. Opening a slot by excavating and removing the upper bentonite layer and stockpiling the excavated materials in a stable area.
- 3. Simultaneously constructing the geosyntheticreinforced MSE wall buttress and backfilling the areas behind and in front of the buttress in the open slot using the materials excavated from the adjacent slot.
- 4. Constructing a low permeability clay cap and top soil to final grade.
