**APPLICATION OF WICKING FABRIC TO REDUCE DAMAGE IN
ALASKAN PAVEMENTS**

Final Project Report

AUTC Project No. xxxxx
Project Title: Application of Wicking Fabric to Reduce Damage in Alaskan Pavements

December 2015

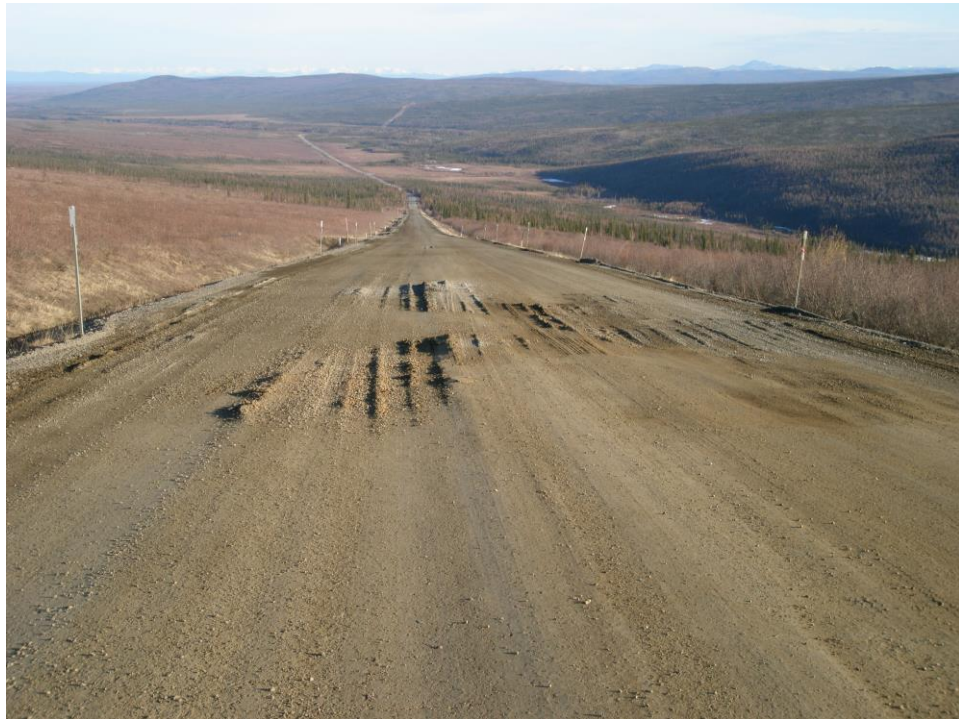
(a) Road conditions On May 12, 2010 (Before Treatment)

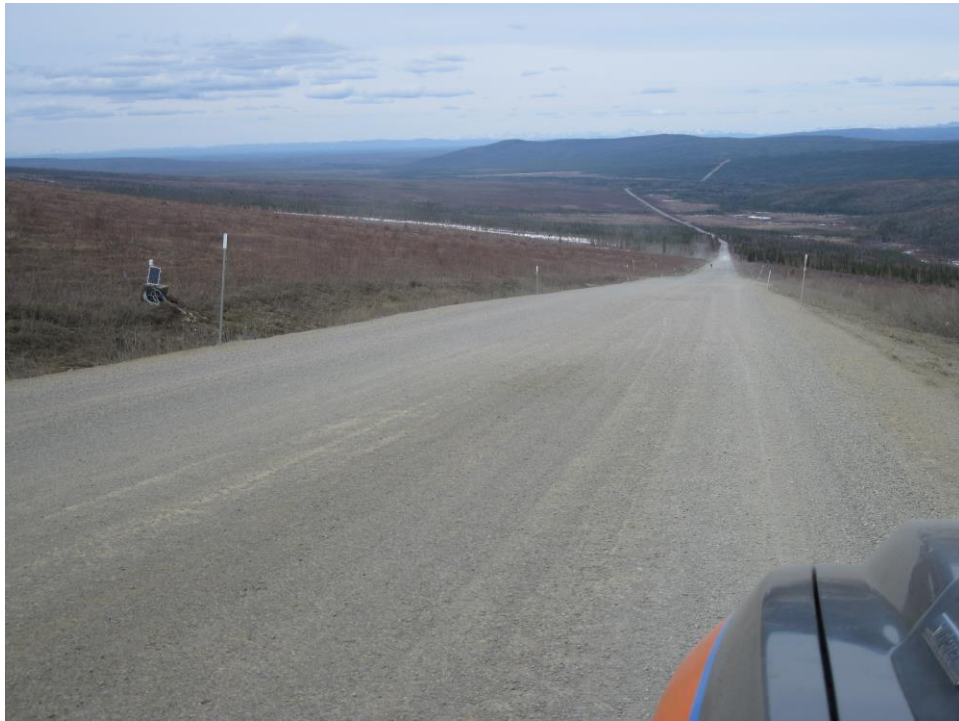
(b) Road conditions On May 24, 2011 (After Treatment)

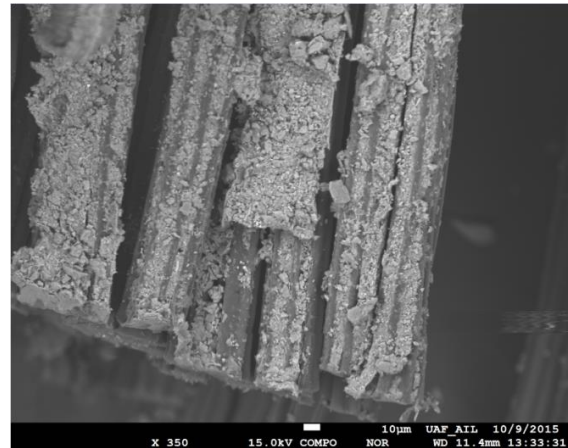
fibers of the wicking fabric at surface served as a protective layer, preventing the fine soil particles from penetrating deeper into the fabric structure. Figure 5.3(d) shows the comparison of the wicking fibers on the surface and the fibers just beneath the surface. It can be visualized from the figures that even though the wicking fabric fibers on surface were filled with fine soil particles, the wicking fibers beneath the surface still work effectively to laterally drain water out of the pavement structure. It is worth noting that it is not fair to evaluate if the wicking fabric is clogged based upon the fibers on the surface since “surface” is a theoretic term and difficult to define during the SEM analyses. If too many soils are left on the surface of the wicking fabric, there is no doubt that the wicking fabric will be covered by the soils. On the other hand, if we take all the surface soil away, the evaluation for the clogging effect is not objective. It seems more reasonable to evaluate the clogging effect based upon the wicking fibers below the surface. From Figures 5.3(c) and 5.3(d), it is concluded that clogging is not a concern for the wicking fabric.

(b) Surface Clogging (Sample 20)

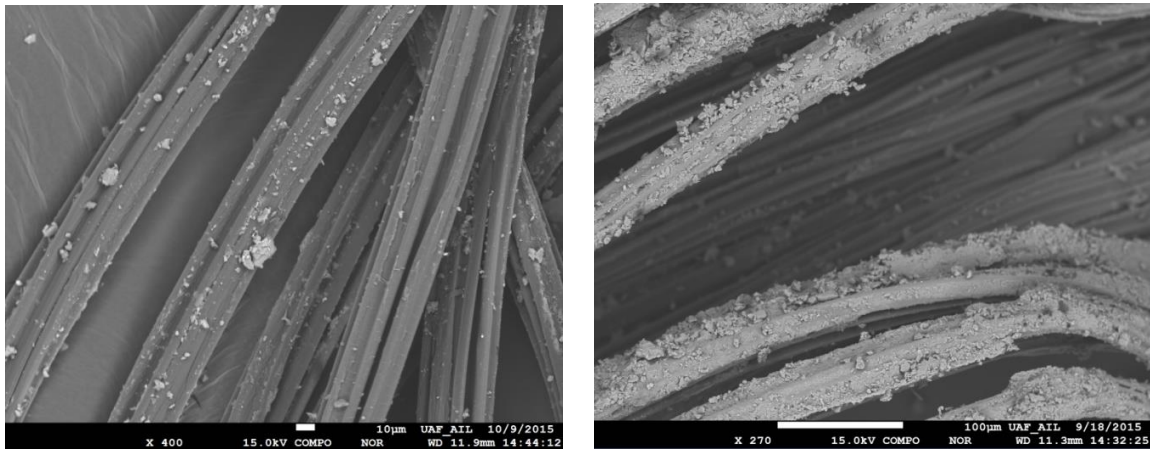
(c) Beneath Surface (Sample 25)

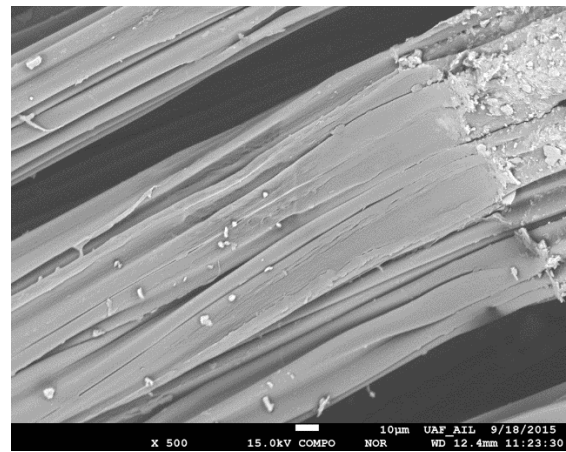
loads applied to the road surface. The drainage paths were broken and became unable to continue to laterally transport water; however, this phenomenon was only observed in 5 of the 30 samples collected from the field. According to the observed macroscopic results at the Beaver Slide, it seems that neither permanent deformation nor puncturation were major concerns, possibly for two reasons (1) there were relatively less percentage of the wicking fabric having permanent deformation or puncturation, and (2), surrounding fine soil particles might have “bridging effect” for water transport at locations where permanent deformation or puncturation occurred.

(b) Permanent Deformation (Sample 1)

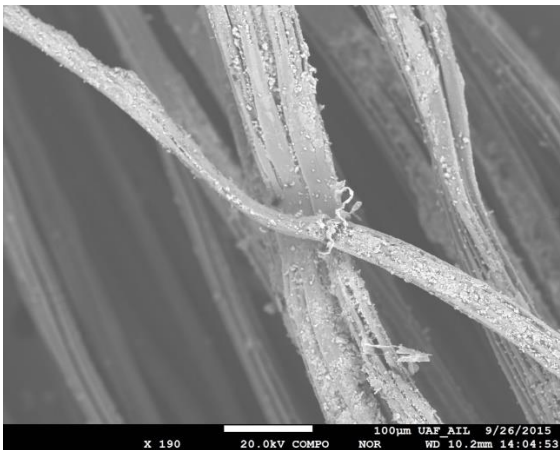
(c) Permanent Deformation (Sample 16)

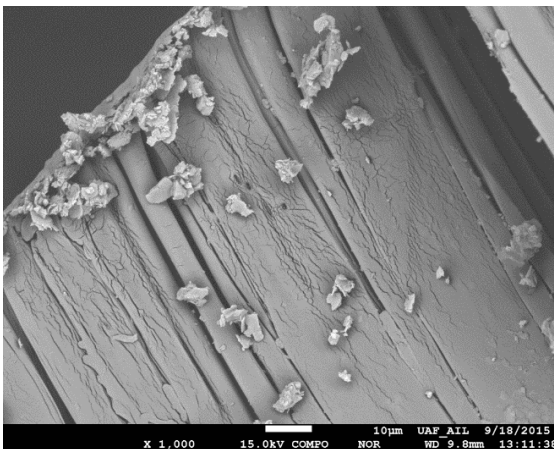
(a) Beaver Slide Sample 3

Because the wicking fabric is buried under the soil, another concern involves the wicking fabric's physical and mechanical aging issue, as shown in Figure 5.5. Figure 5.5(a) shows the aging severity of the wicking fabric fibers under the woven polypropylene yarns. Because the wicking fibers on the surface were directly in contact with the soil particles, the aging phenomena were usually observed in the fibers located at the surface of the fabric. Figure 5.5(b) shows the wicking fabric fibers at the surface without the woven polypropylene yarns. As believed, the aging phenomenon was likely due to direct contact with the soil particles. The aging effect at the bottom of the deep grooves was more severe than in the other areas of the wicking fabric. In comparison, Figure 5.5 (c) and (d) show the wicking fabric beneath the surface. No obvious aging effect was observed below the surface layer, and the deep grooves were much cleaner than those of the fibers on surface.
