# Environmental Dredging and Remediation TenCate Geotube® Case Studies

# TenCate Geotube® technology

# Environmental dredging and remediation

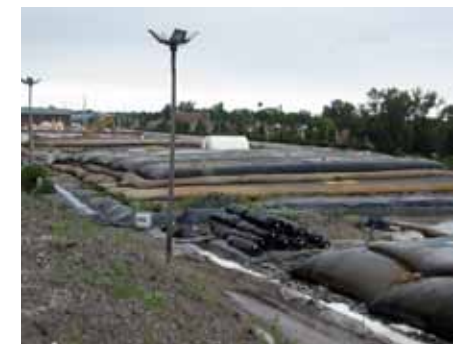
Geotube<sup>®</sup> containers stacked three high on dewatering platform

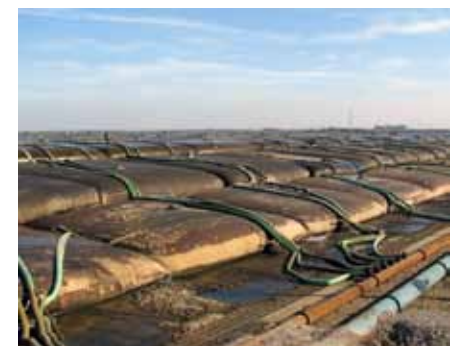
Three layers of Geotube<sup>®</sup> containers on the dewatering platform
