**APPLICATION OF WICKING FABRIC TO REDUCE DAMAGE IN
ALASKAN PAVEMENTS**

Final Project Report

AUTC Project No. xxxxx
Project Title: Application of Wicking Fabric to Reduce Damage in Alaskan Pavements

December 2015

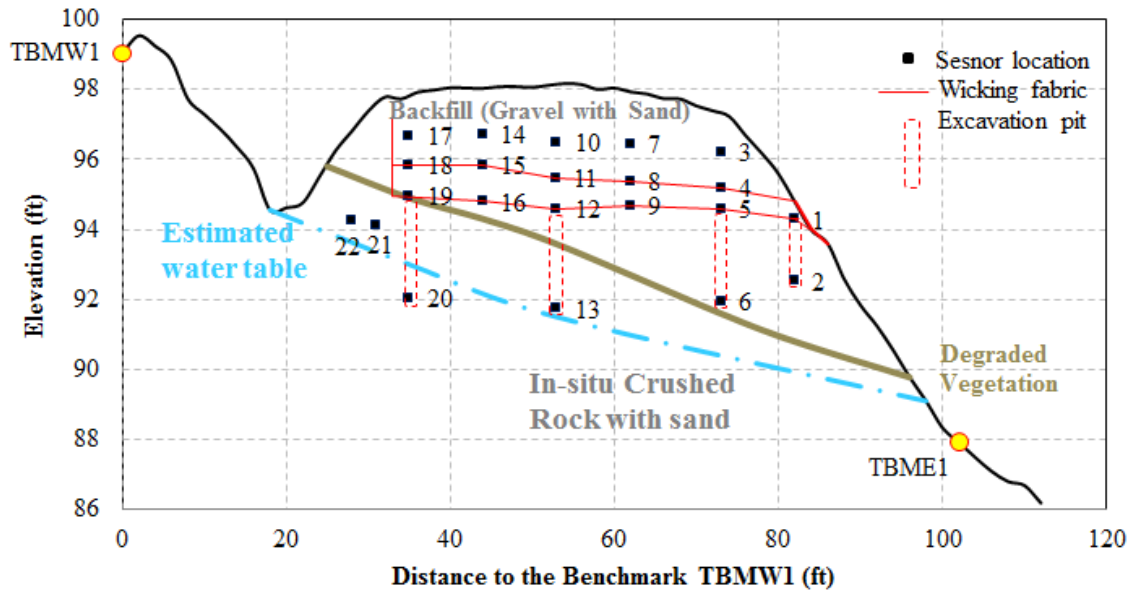
Figure 3.10 Sensor Locations, Groundwater and Soil Stratigraphy

Figure 3.10 shows the soil stratigraphy at the test section location, based upon the observations made during the construction process. It was found that the road section was built directly on the original tundra on the hill, using the degraded granite which was classified as silt with gravel, according to USCS classifications. Sieve analysis of the soils (Figure 3.11) indicated that some soils have fines contents greater than 6%, indicating that some soils at the site may be frost susceptible. Ground water was also encountered when installing sensor 20. Figure 3.10 above shows the approximate ground water table based upon these observations.

The original tundra was encountered at about 0.91 meters (3.0 feet) below the ground surface at the west edge of the road, and at 1.36 meters (4.5 feet) below the surface at the centerline of the road section. It was about 2.72 meters (9 feet) lower than the road surface where it extended to the tree line at the west shoulder of the road. The buried vegetation encountered was degraded into a dark-yellow layer, which was about 0.05-0.1 meters (1-2 inches) thick. *In situ* crushed rocks with sand were encountered below the vegetation. Ground water was observed 0.15 meters (6 inches) below the tundra surface, once the tundra was removed. Additionally, standing water was observed during the construction process in the existing drainage ditch along the west side of the road. On the east side of the road, water was sporadically present along the tree line.

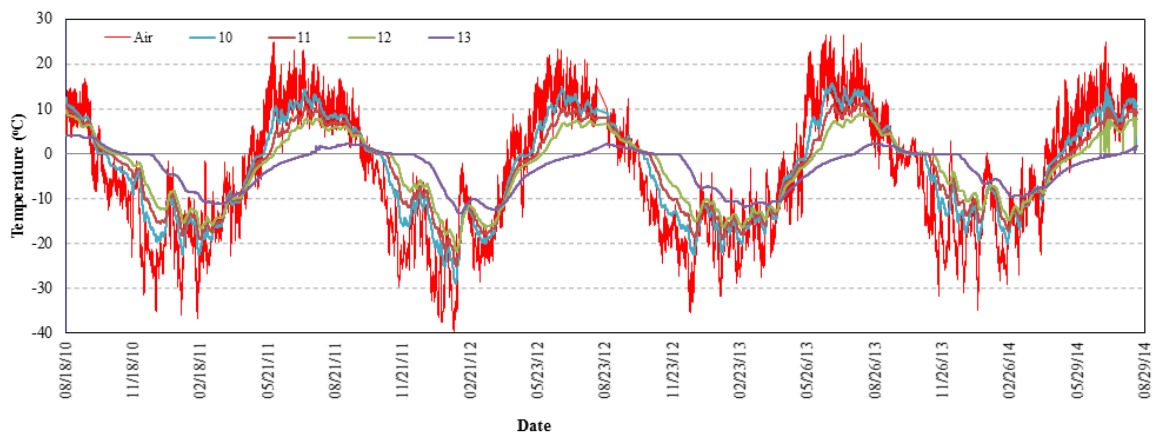
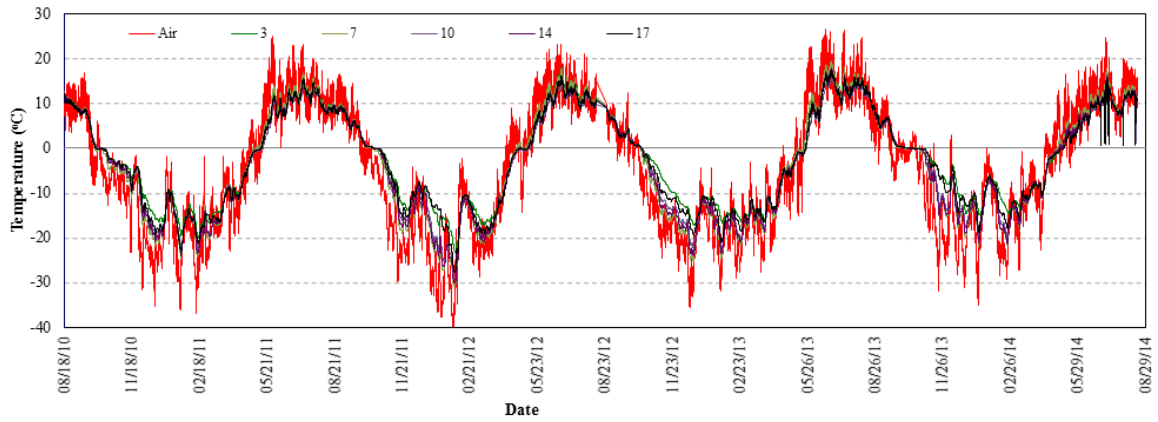
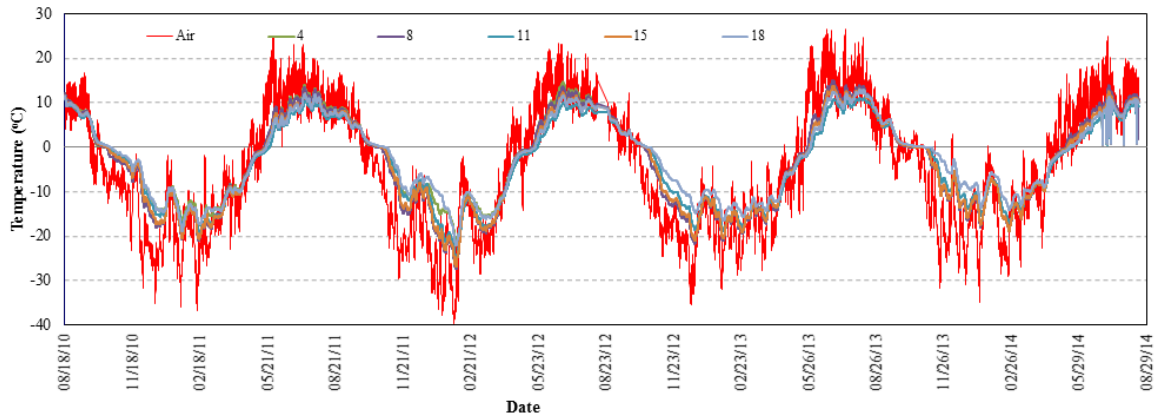
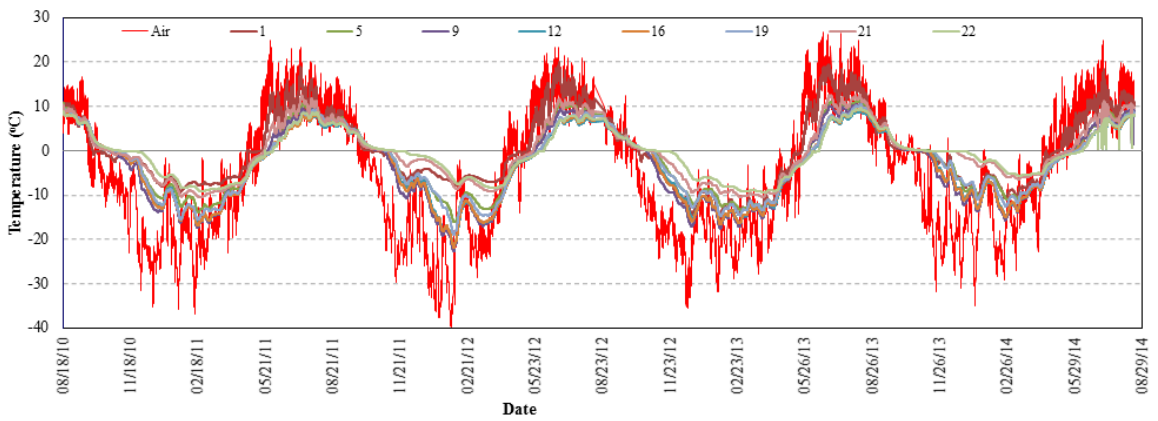
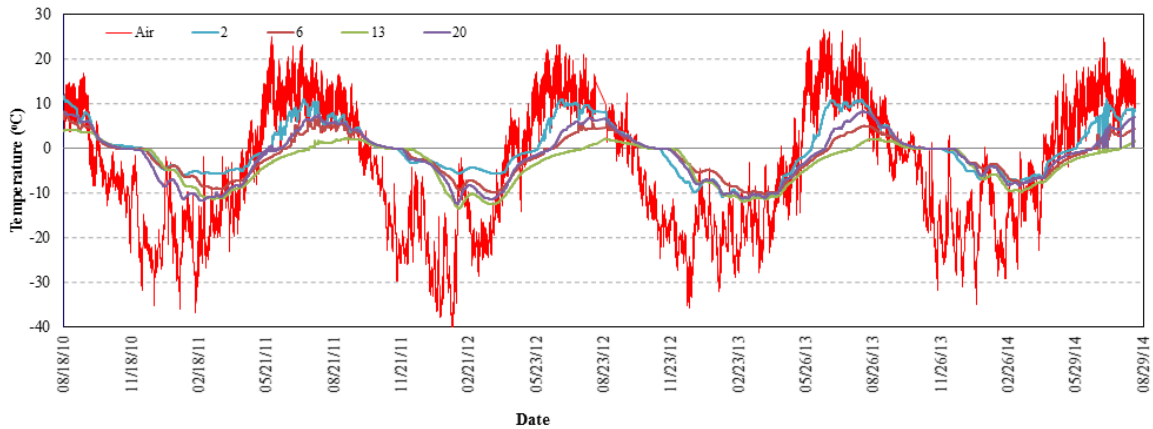
Figure 4.2 Soil Temperature Changes

Figure 4.2 (b)–(c) present temperature changes for the sensors located at 0.45 meters and 0.76 meters (1.5 feet and 2.5 feet) below road surface. In general, the amplitudes of temperature changes at 0.76 meters (2.5 feet) meters were smaller than that at 0.45 meters (2.5 feet). However, the soil temperature changes in both layers followed the air temperature trend during the summer, and were warmer than the air temperature in winter months. Thus, soils 0.76 meters (2.5 feet) below the road surface could be considered as permeable layers during the summer and be able to drain the melting snow at the surface of the roadway. Additionally, the soil temperatures observed in the center of the road were lower than temperatures at the edges during winter months, and soil temperatures at the west side of the road were lower than those at the east side. There are two reasons to explain this phenomenon: (1) snow was routinely removed and piled on the shoulders, insulating the shoulders to make them warmer than the center of the road; and (2) the roadway on the east side received more solar energy than the west side, resulting higher temperatures at the east side of the roadway.

obvious as depth below the surface increases. As can be seen in Figure 4.2(d), soil temperatures changes at 1.06 meters (3.5 feet) experienced approximately a 1 month time lag (time difference for the starting dates of soil and air temperatures above zero) compared with the air temperature changes. As for soils at a depth of 1.97 meters (6.5 feet), this time lag could be as large as three months, as shown in Figure 4.2(e). This phenomenon indicated that during the early spring (late April or early May), the soils at 1.06 meters (3.5 feet) and below were still frozen and could not be considered as a drainage layer until 1-3 months later. In other words, since the second layer of wicking fabric was installed at 1.06 meters (3.5 feet) below the road surface, it would not be able to drain the water out of the embankment until early June. The first snowfall at the site is expected in early October each year, theoretically allowing the second layer of wicking fabric to remain functional till early November, when the soils at this depth become thoroughly frozen.

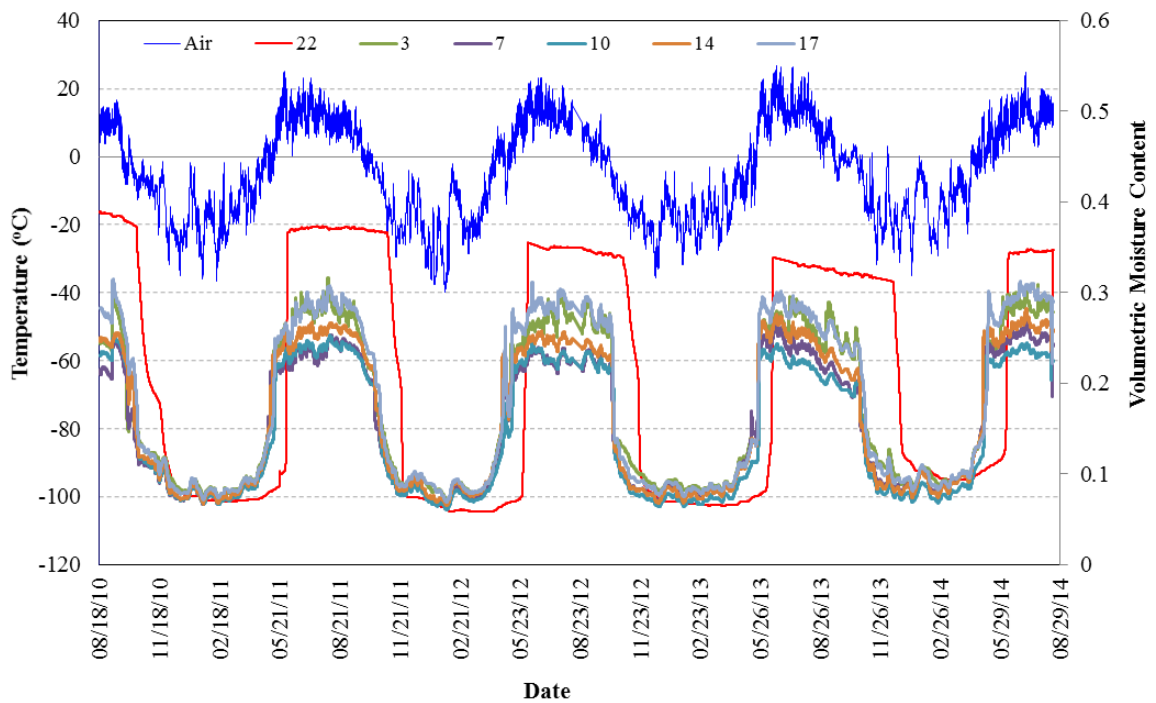
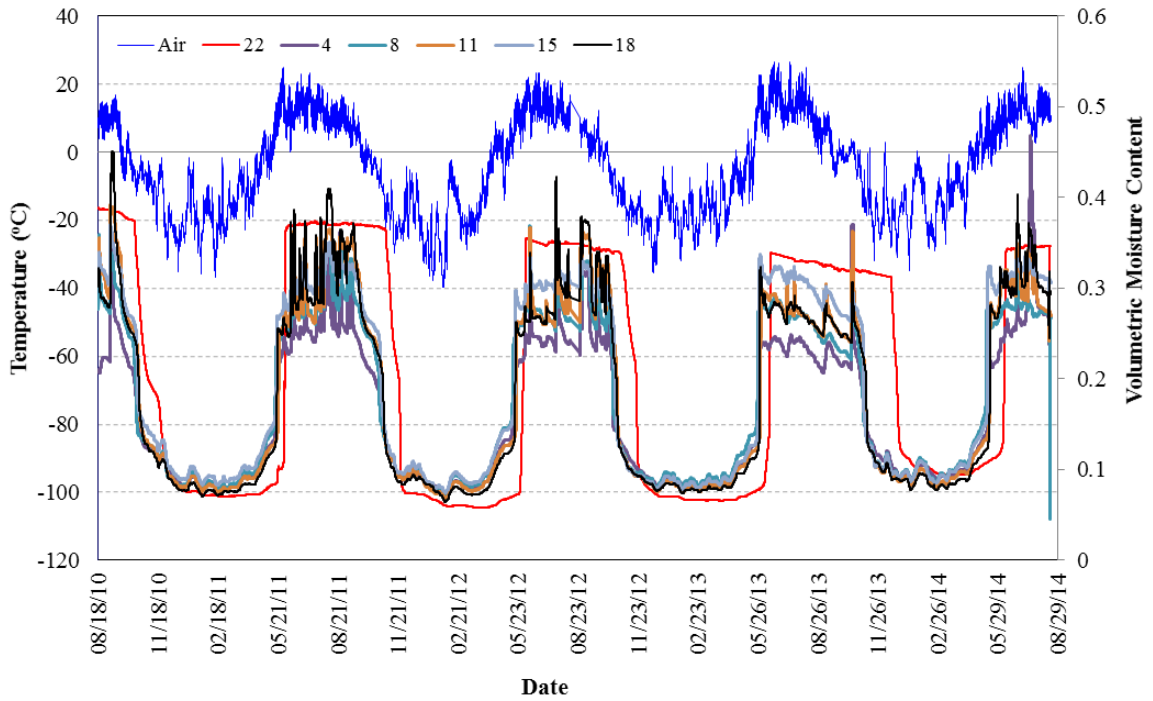
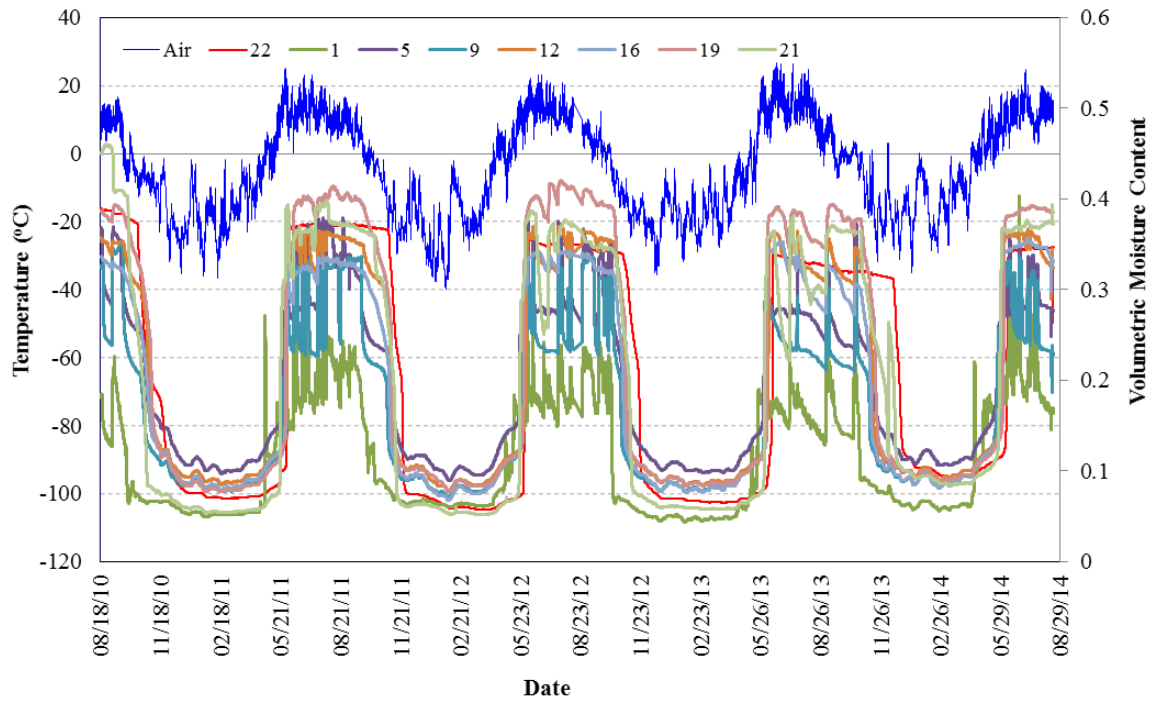
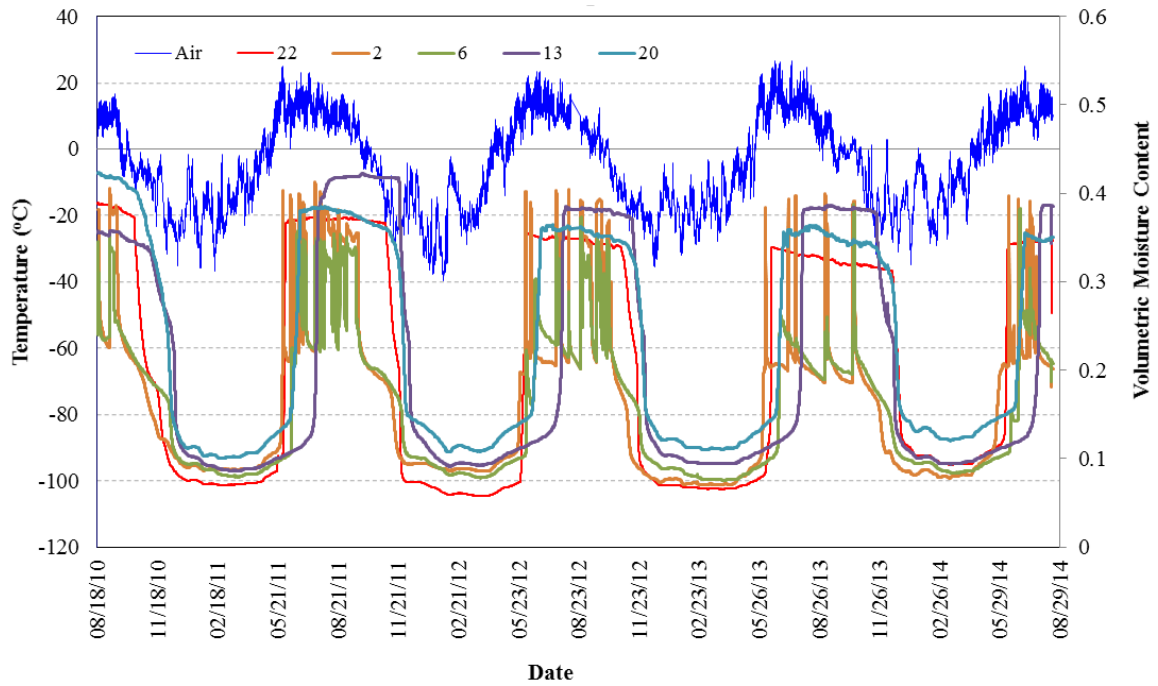
Figure 4.3 Soil Moisture Changes

Figure 4.3(a) shows the soil moisture changes at 0.46 meters (1.5 feet) below road surface. It is obvious that the moisture contents at this depth were far below the moisture content at the reference location (sensor 22). This means that during the 4-year period, the soils always remained unsaturated. It is well known that when the soil moisture is low, its modulus and shear strength are significantly higher. Figure 4.3(a) is consistent with the observations made by AKDOT&PF maintenance and operation personnel who were very satisfied with the performance of the test section in the past five years. The test results indicated that the water from precipitation could be easily runoff due to the existence of both longitudinal and transverse slopes. Because the ground water table on west side was higher than on east side, and the frozen soil in the center of the pavement structure impeded the natural water flow, it is reasonable that the moisture contents of the soils on west side were higher (see moisture content at sensor 17).

of sensor 22, except for some long and intensive rainfall events. Any sudden, large variation in soil volumetric moisture content change indicated a rainfall event. Compared with Figure 4.3(a), soils at this depth, 0.76 meters (2.5 feet) were more affected by the rainfall events than soils at 0.46 meters (1.5 feet). However, the soil moisture contents dropped back quickly after the rainfall event stopped, which indicates that the drainage condition at this depth was favorable. Since the soils at 0.45m remained unsaturated in the four years as shown in Figure 4.3(a), the excessive water at the depth of 0.76m was from the horizontal direction.

Figure 4.3(c) shows soil moisture changes at 1.06 meters (3.5 feet) below road surface, where the second layer of wicking fabric was installed. Sensor 1 was buried fairly shallow on the east side of the road shoulder, and the moisture content was much lower than that for the reference sensor 22. Similarly, the moisture contents for sensors on the east side were all lower than at the location of the reference sensor, and the moisture content for sensors on the west side were all higher than at the location of the reference sensor. The amplitudes of moisture content changes after intensive rainfall events were also higher at 1.06 meters (3.5 feet) than at the previous two depths discussed. This phenomenon could be a result of (1) accumulated water at the drainage ditch, and (2) the one-month time lag to melt the frozen soil at this depth. Since the snow started to melt in late April, large amounts of water was trapped in the drainage ditch, which provided excess water to the roadway structure. Additionally, the temperature at the center line of the road was lower than that at the edges. Soil at 1.06 meters (3.5 feet) and below would not start to melt until late May or early June. The freezing temperatures and excess water resulted in a hard, frozen core at the center of the road, impeding the drainage path. Therefore, additional water was trapped in the area adjacent to and including the west side of the road, and resulted in higher moisture contents.

Figure 4.3(d) shows the moisture content changes for sensors at 1.97 meters (6.5 feet) below road surface. The moisture content distributions followed the trend presented in Figure 4.3(c). All of the sensors on west side had moisture contents higher than those on east side. It is noteworthy that sensor 13 (located at the centerline of the embankment) did not fully melt until mid-August, which is nearly 3 months after snow melting began.

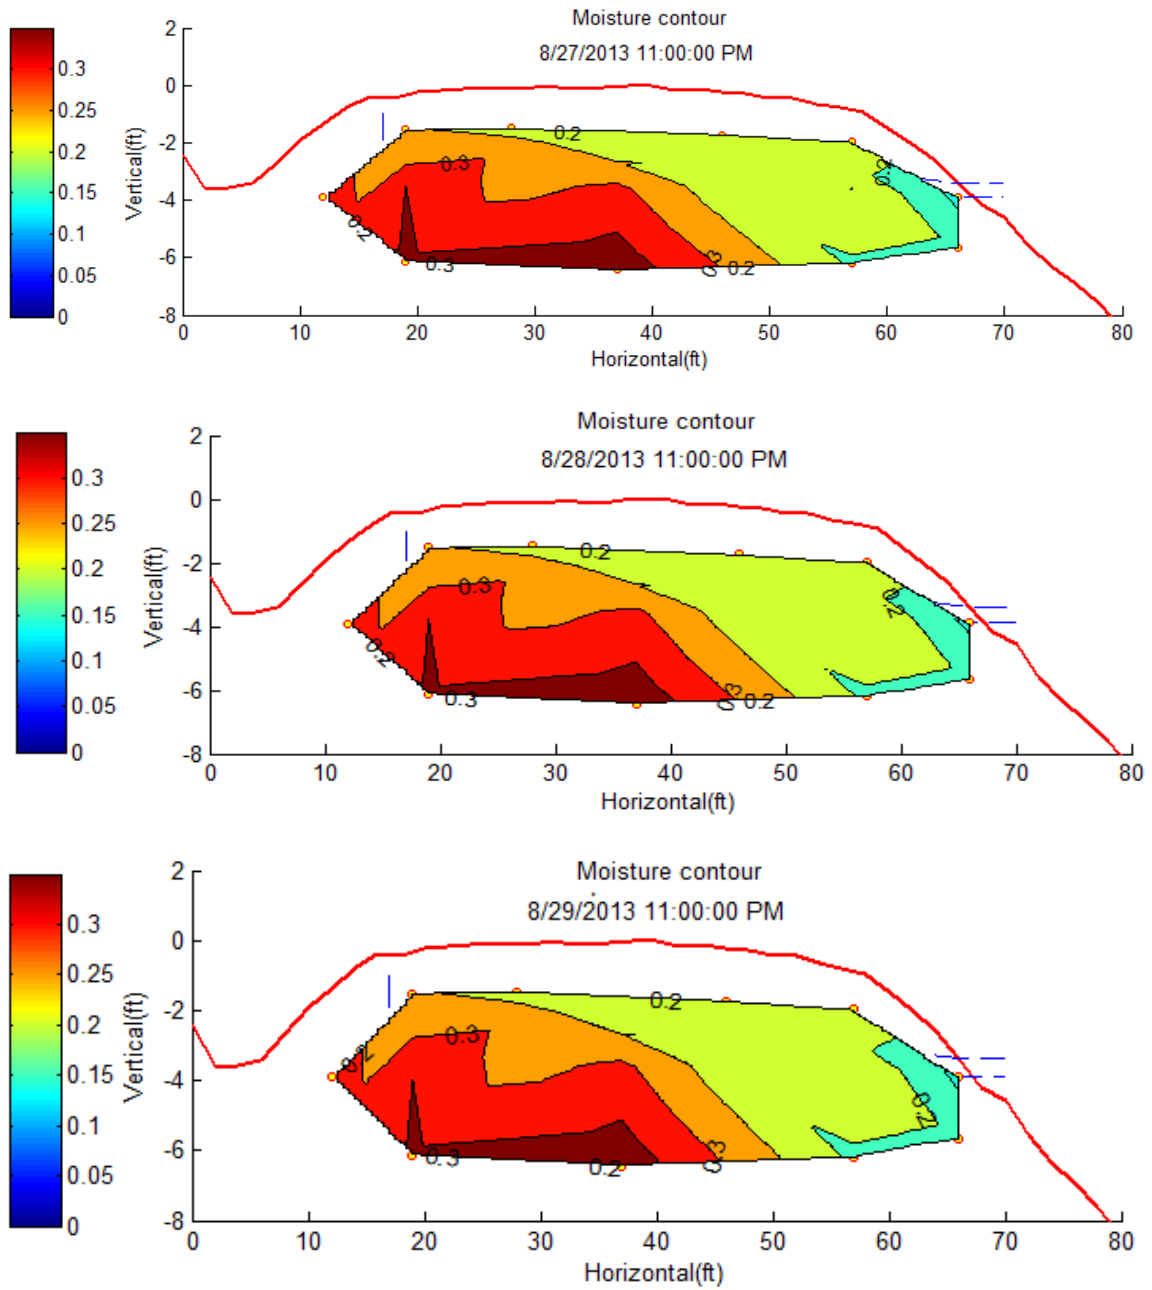
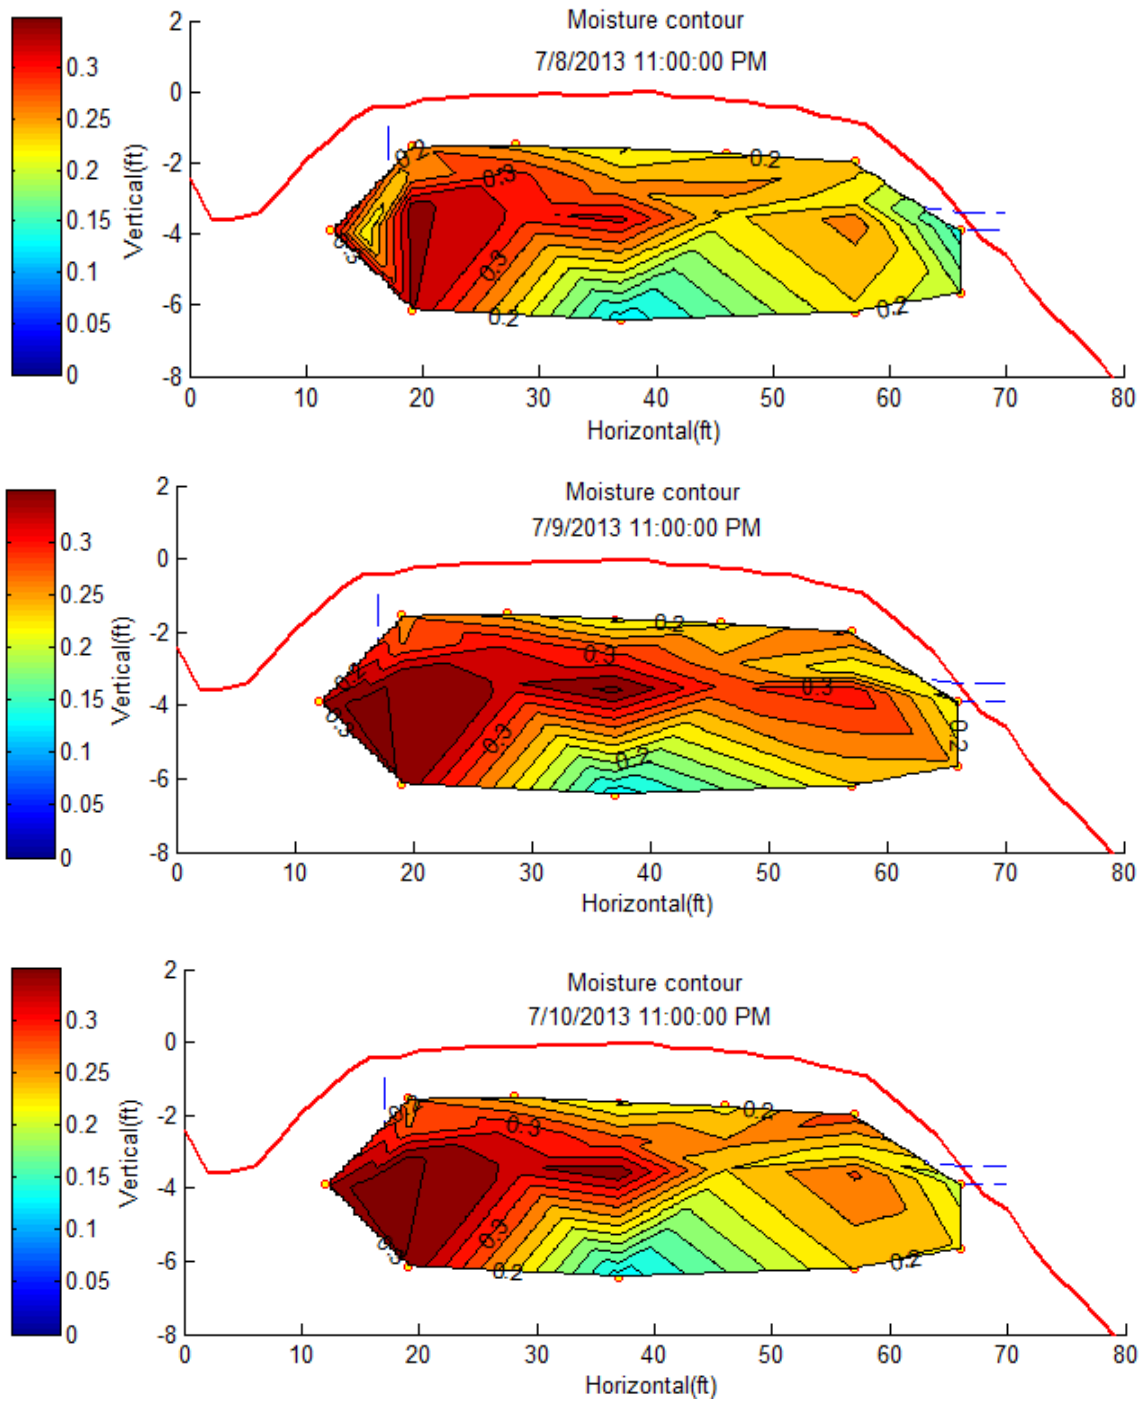
Figure 4.4 Soil Moisture Contours during Rainfall Events

In a summary, the effect of rainfall intensity was limited due to the good drainage base course material (gravel with sand). Therefore, only the effect of rainfall duration is discussed in this section. Figure 4.4 shows the comparison of two rainfall events to demonstrate this effect: one is a short-term rainfall event lasting several hours, and the other is a relatively heavy rainfall event lasting for several days. As shown in Figure 4.4(a), the first recorded rainfall occurred at 10 pm on August 28, 2013 and lasted for 5 hours. By looking up the recorded data, it was determined that no other significant rainfall events occurred within a week prior to this rainfall event. The 3 moisture contour figures demonstrate the soil moisture distributions before the rainfall, 1 hour after the rainfall and 1 day after the rainfall. It was apparent that the soil moisture distribution did not change significantly as a result of this event. This phenomenon indicated that a 5-hour rainfall was not long enough to change the water moisture distribution within the pavement structure. In comparison, another rainfall occurred at 11 pm on July 8, 2013 and continued on the following day. The total rainfall duration was about 27 hours from July 8 to July 9, ending around 2 pm on July 9. Figure 4.4(b) shows the soil moisture distribution at the beginning of the rainfall event, 7 hours after the rainfall and about 1 day after the rainfall. The soils in east side of the roadway were significantly drier than the soils on west side of the roadway prior to the rainfall. 7 hours after the rainfall event, more water had accumulated in both the east and west sides of the road structure. The saturation zone in the west side was larger because water flowed into the pavement structure via a drainage ditch up-slope and adjacent to the west side of the embankment. Meanwhile, on east side of the road, the saturated zone was observed at the location of the wicking fabric layers. This phenomenon indicated that the wicking fabric was able to suck the water from the surrounding soils and laterally transport it to the shoulder. The third contour figure shows that 1 day after the rainfall event, the saturation zone was smaller than before in the west side of the roadway. The soils near the wicking fabric were comparatively drier than the rest of the soils on east side of the embankment, where no apparent saturation zone was observed.

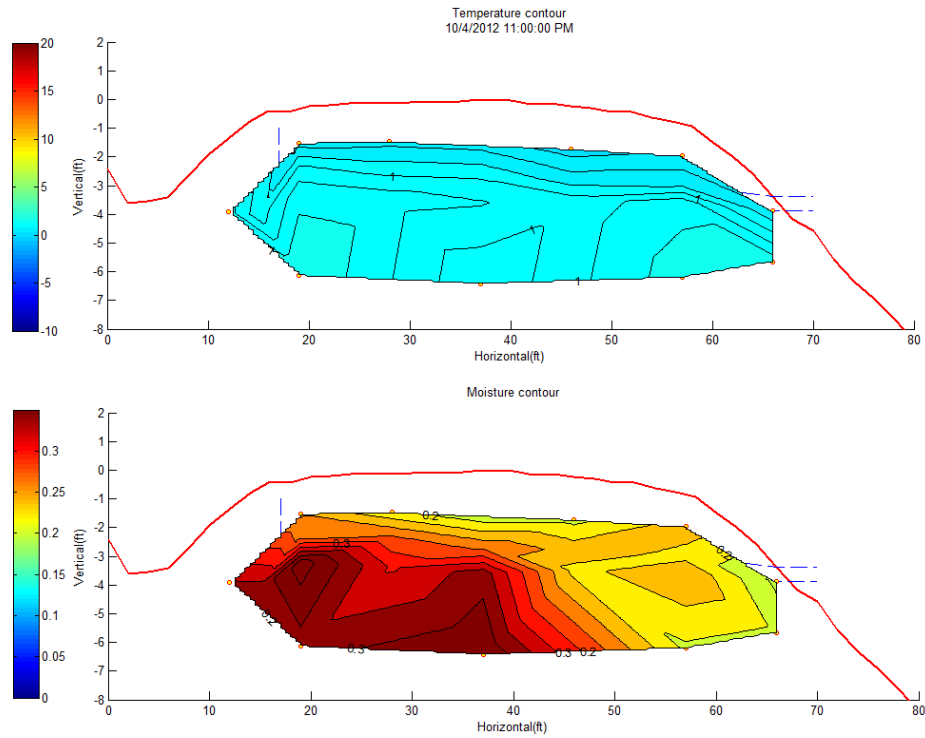
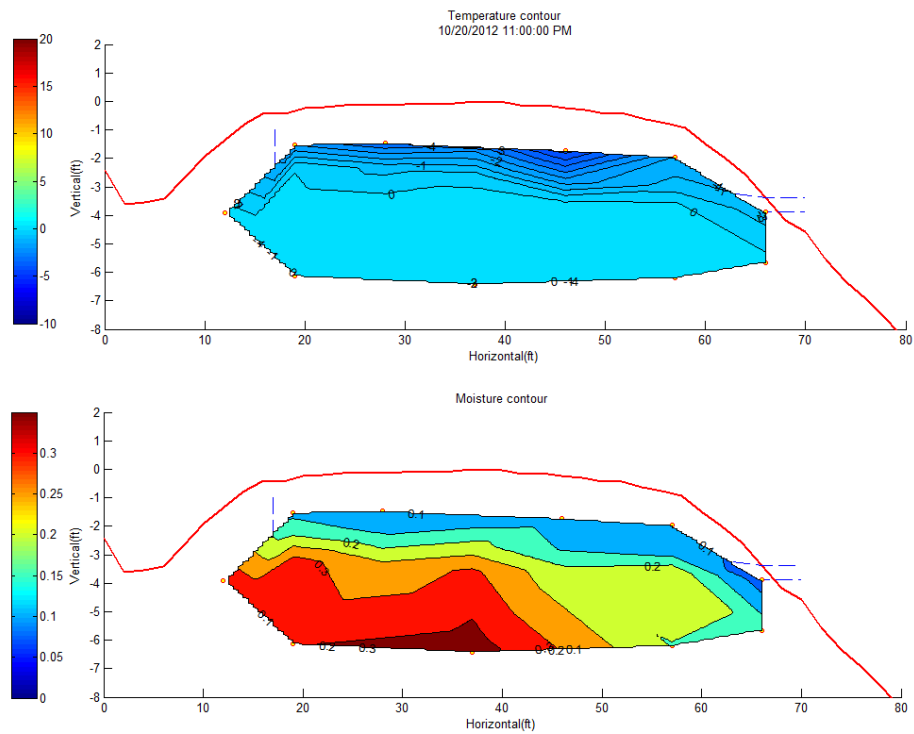
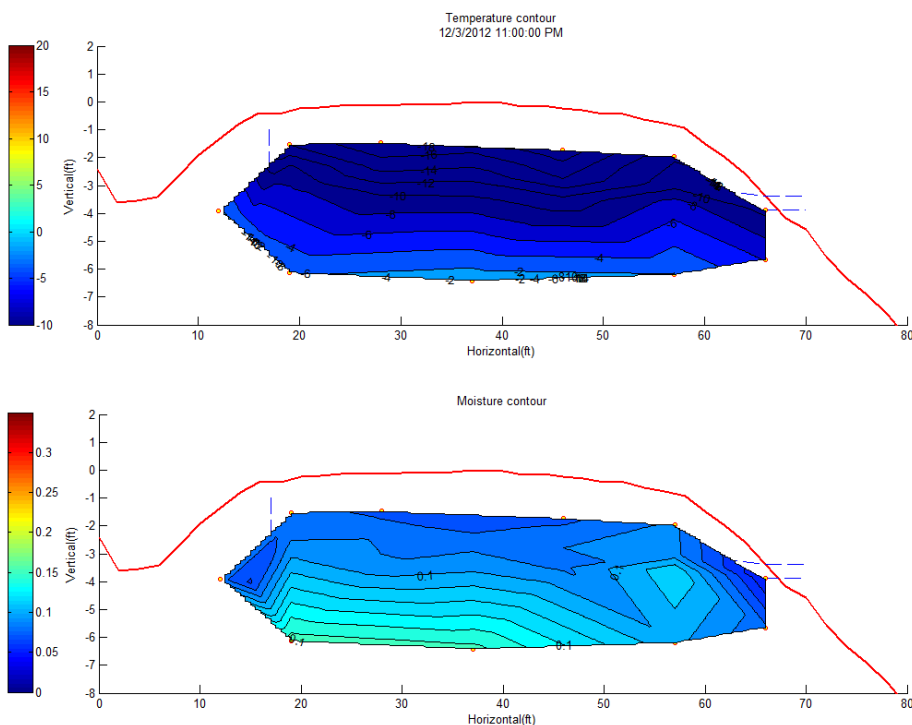
Figure 4.5 Temperature and Moisture Contour during Freezing Process

For purposes of this discussion, we focused on 2012 data in our analysis of the freezing process. The air temperature dropped below zero on October 4, 2012; however, the temperature in the soil was still above zero, as shown in Figure 4.5(a). It is critical to determine the moisture content distribution before the freezing front moves downward, because the water stored in the soil (both frozen and unfrozen) is the major factor influencing the severity of the “frost boiling” phenomenon in the subsequent spring. There were still two major saturation zones in the west side of the road; however, the moisture content in the east side was relatively low (about 0.2). This indicated that soft spots in the following spring, if frost boiling was observed, would be expected first in the west lane of the road surface. Also, it would take a much longer time for the freezing front to move downward in the west side, as shown in Figure 4.5(b). It was discovered (Zhang et al. 2014) that the freezing front (0 °C isothermal curve) nearly coincides with the location of the 0.2 volumetric water content curve. The freezing front extended to about 0.76 meters (2.5 feet) below the road surface on October 20, 2012 on west side, and to approximately 1.07 meters (3.5 feet) on east side. Moreover, the saturated zone was observed extending to the bottom sensor in the west side. Since the latent heat of water is relatively large compared with soil, it would take much more energy to freeze the soil on west side, where the moisture content was higher. Furthermore, the area exposed to the freezing air on east side was larger than on west side, so it is reasonable to assume that the freezing front moved faster on east side of the road. If this holds true, the wicking fabric would stop functioning in early October, due to the frozen drainage paths where the fabric is exposed to the freezing air on the east side of the road. Figure 4.5(c) shows that the entire pavement structure was frozen on December 3, 2012, which was about two month after the air temperature dropped below zero. The unfrozen volumetric water content in the frozen soil was consistent, averaging about 0.07.

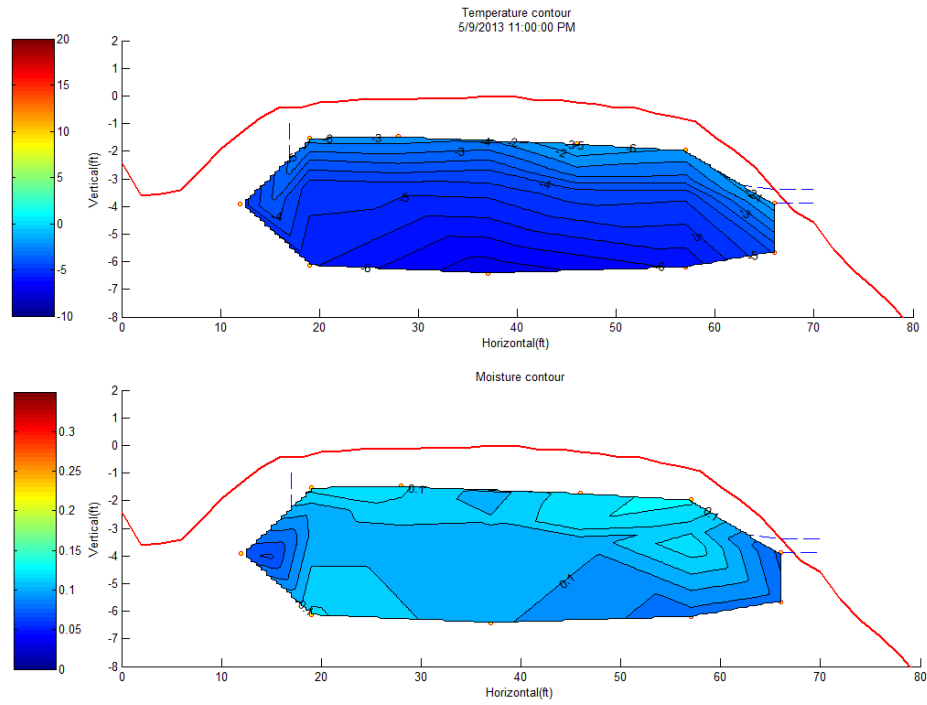
(a) Temperature and Moisture Contour on May 9, 2013

Figure 4.6 shows the temperature and moisture contours during the thawing process in 2013. The mean daily air temperature rose above 0°C on May 9, 2013, as shown in Figure 4.6(a). The temperature in the soil was still below 0°C and the unfrozen water content of the soil was still about 0.07 to 0.10. Figure 4.6(b) shows the temperature and moisture contours on May 25, 2013. The thawing front had penetrated to about 0.61 meters (2 feet) near the west edge of the road, and to 1.06 meters (3.48 feet) at the east edge. It was mentioned in a previous study (Zhang et al. 2014) that the frost boil phenomenon was observed during this time of the year. Similarly at sensor 22, located nearest to the drainage ditch, the unfrozen water content remained below 0.1, which indicated that the drainage ditch was still frozen at this time, and that there was no water supply from melting snow. All of the sensors showed that the moisture contents were below saturation. This demonstrates that no soft spots could be observed at this time of

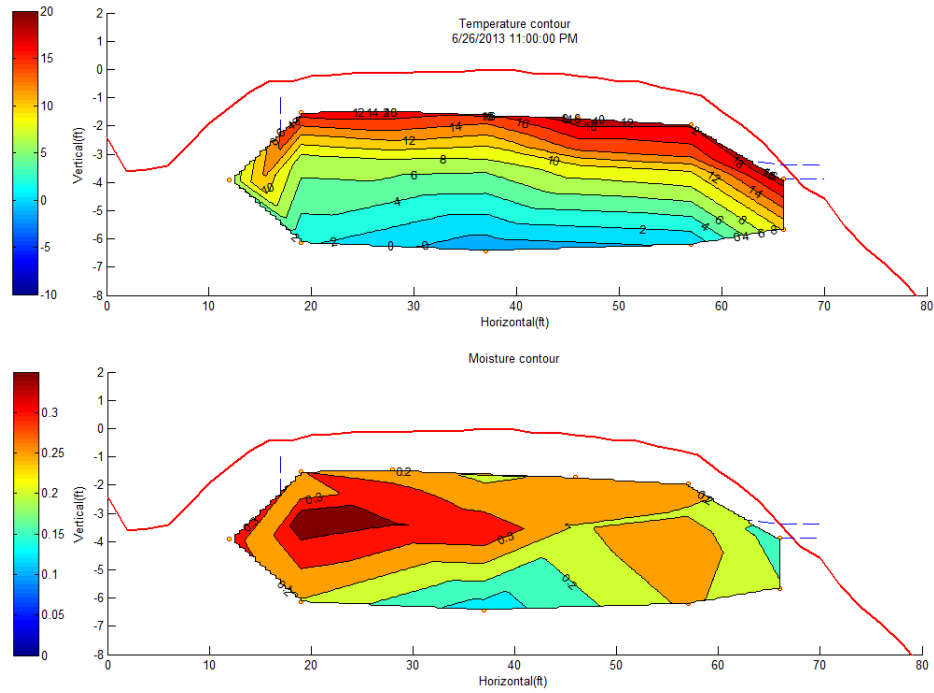
(c) Temperature and Moisture Contour on June 26, 2013

the year. Figure 4.6(c) shows the temperature and moisture contours on June 26, 2013. The thawing front had protruded to 1.83 meters (6 feet) below the road surface, and a frozen core was evident in the center of the roadway. Again, since the moisture contents on west side of the road embankment showed large amounts of excess water during the previous freezing process, and because the west side is located adjacent to the drainage ditch, the moisture contents were expected to be higher than those on east side. Additionally, the frozen hard core in the center of the road embankment cut off the free water flow laterally and trapped the underground water at the east side of the roadway. Figure 4.6(d) shows the temperature and moisture contour on July 30, 2013. The thawing front had penetrated to 1.97 meters (6.4 feet) below the road surface, and the frozen core was thoroughly melted. The trapped saturation zone was released and was allowed to flow laterally out of the embankment. Meanwhile, the water stored in the drainage ditch and the ground water also provided additional water supply to the pavement structure; therefore, the saturation zone was expected to be even larger than before. Because of the presence of the wicking fabric, the east side of the embankment was relatively dry, demonstrating that the wicking fabric worked effectively to suck water out of the pavement structure.

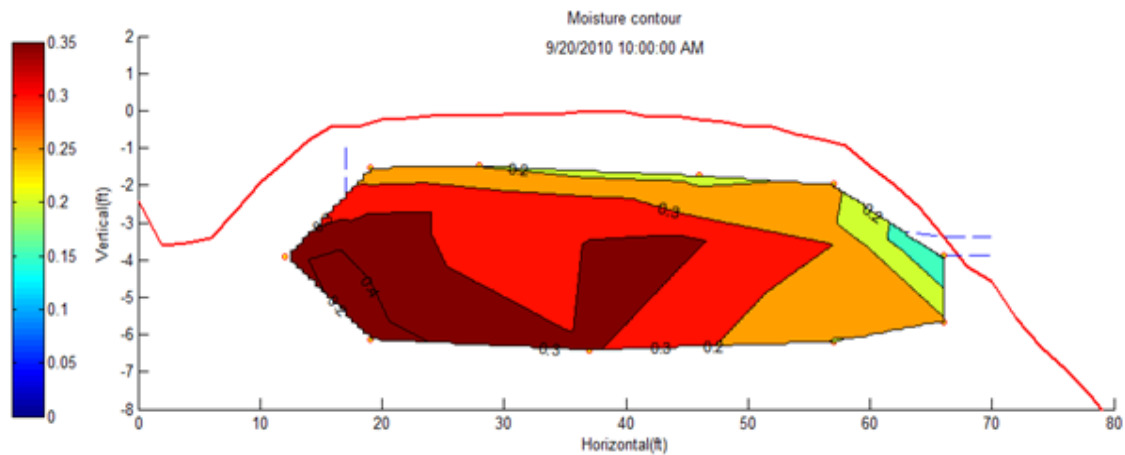
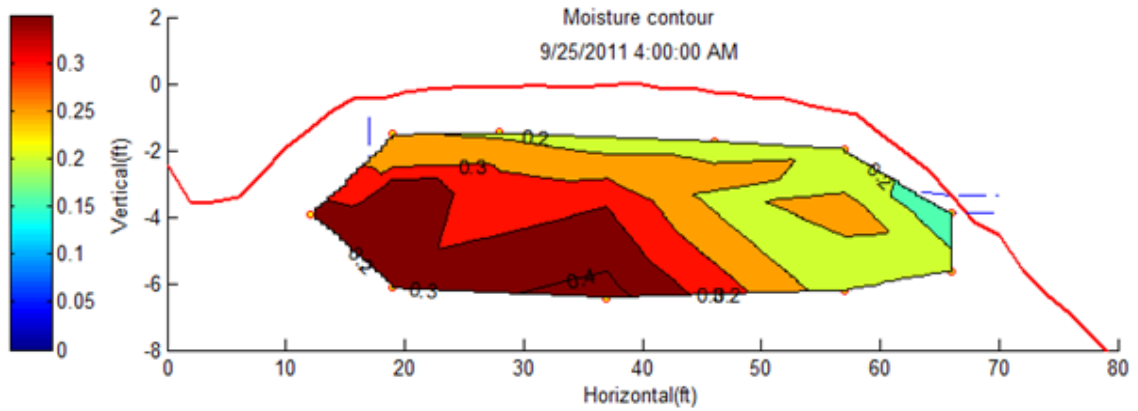
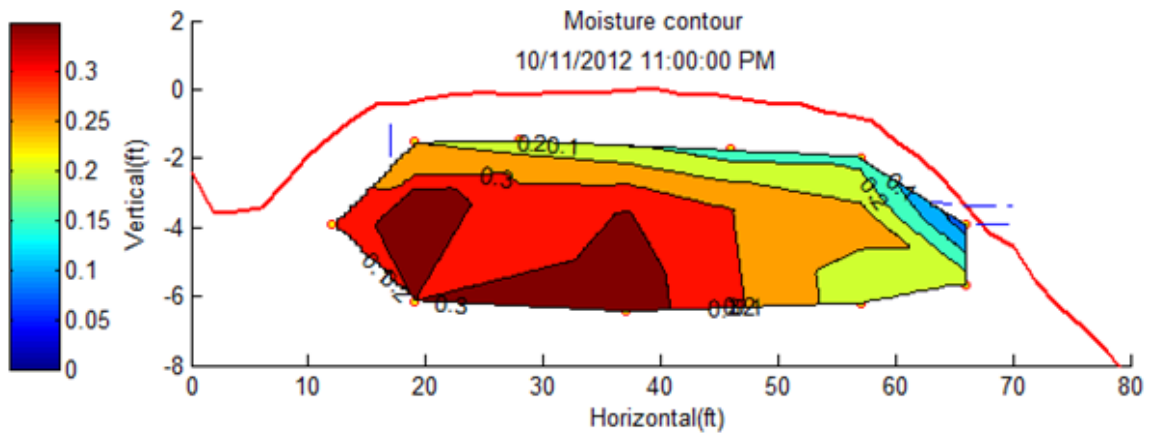
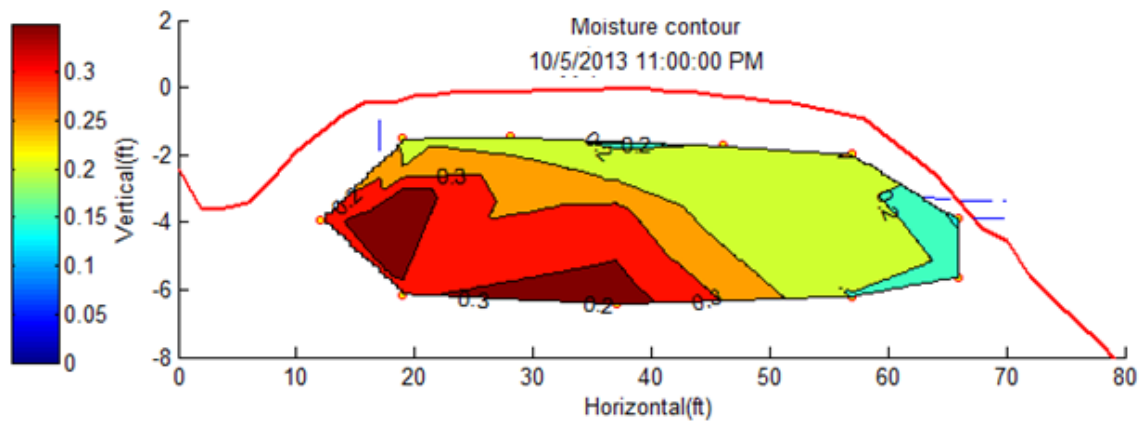
Figure 5.1 Moisture Contours before Freezing

It is critical to determine the moisture content distribution before the freezing front moves downward, because the severity of the thaw weakening in the following spring is directly related to the amount of water stored in the pavement structure before the freezing process started in the previous year. In other words, the soft spots in the following spring, if frost boiling was observed, would be expected where the saturation zones were observed before the freezing process started in the previous year. For purposes of this discussion, the moisture contours when the air temperature dropped below zero during the recorded four-year period were summarized and compared, as shown in Figure 5.1. It should be noted that the areas of the saturation zones decreased with time. For instance, there were two saturation zones that were connected together in 2010 and 2011 (Figure 5.1 (a) and (b)); however, the saturation zones became separated into two smaller zones on in 2012 (Figure 5.1(c)). The less the amount of water stored in the pavement structure, the less severity of the frost heave would be expected during the freezing process (less negative pore water pressure would be generated due to the water

phase changing from liquid state to solid state). Moreover, since the soil moisture contents were lower than the previous years, it took less energy to move the freezing front downward. In comparison, the freezing front had already penetrated to 0.9 meters (2.95 feet) on October 11, 2012, which was about 0.3 meters (0.98 feet) deeper than the previous year. Furthermore, the saturation zone continued to decrease at the bottom of the roadway in year 2013, as shown in Figure 5.1(d). This phenomenon could be apparent because: (1) precipitation variation may cause such variations in the soil moisture content distribution, (2) the wicking fabric worked effectively to reduce the moisture content in the soil. Because the rainfall event summary presented in Table 4.1 indicated that there were no significant rainfall events that occurred right before the selected days, precipitation was not the reason that caused the decrease in soil moisture contents. Therefore, the wicking fabric did reduce the water content on east side of the roadway embankment, and reduced the size of saturation zone on west side of the road. However, the performance of the wicking fabric to drain the water out needed to be further evaluated during the spring thawing process to validate its efficiency.

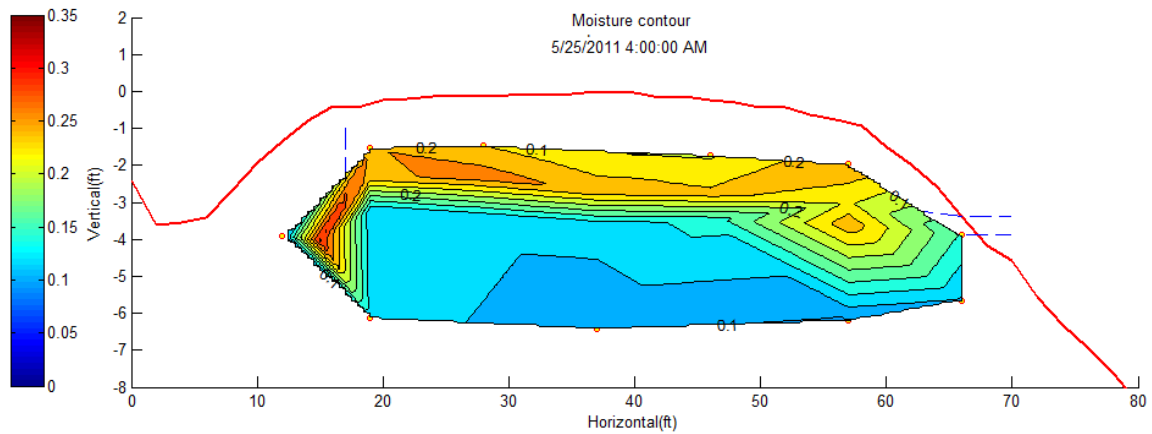
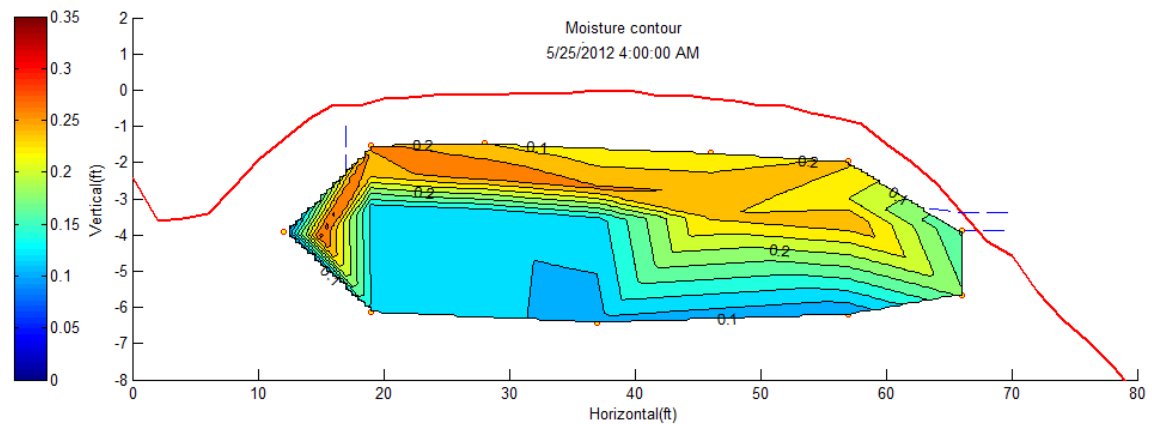
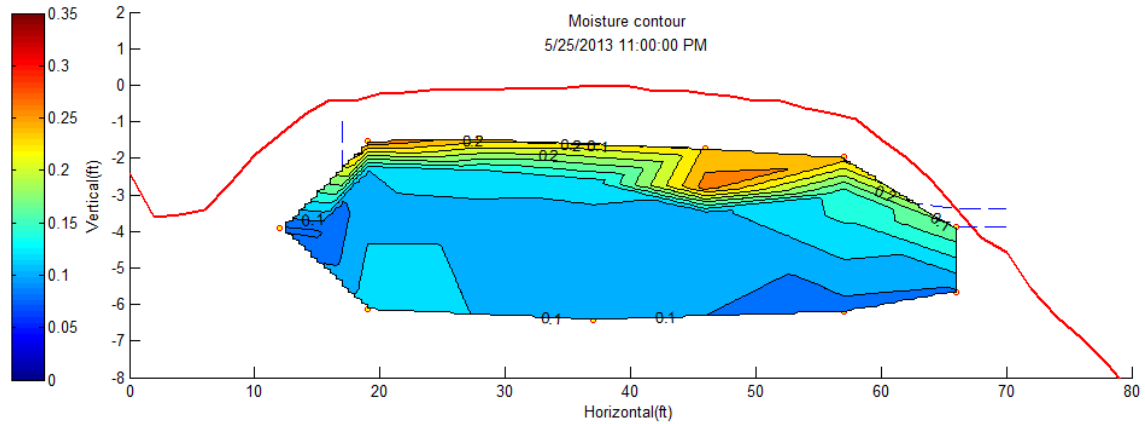
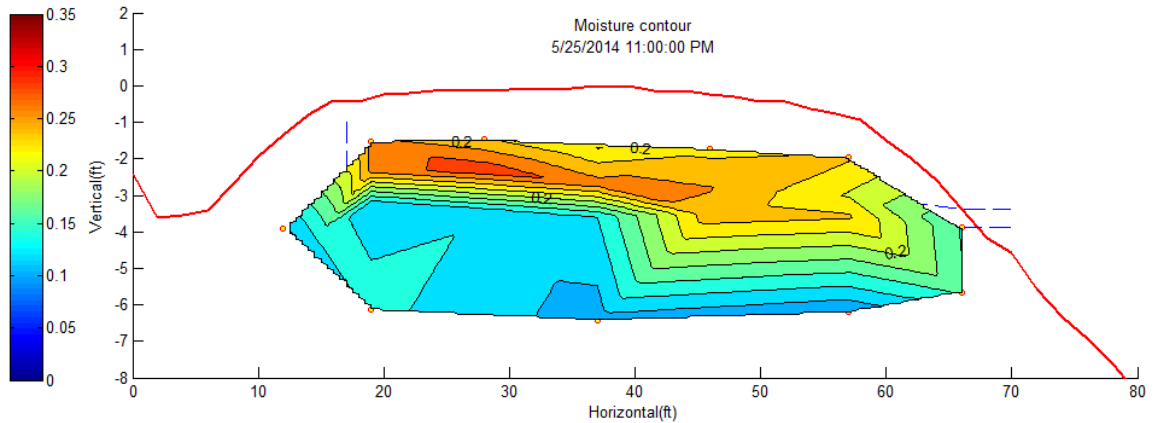
Figure 5.2 Moisture Contours during Thawing Process

Figure 5.2 shows the moisture contours in late May of each year. Firstly, the unfrozen water contents for sensor 22, which located nearest to the drainage ditch, remained below 0.1 within the monitored four years. This phenomenon indicated that the drainage ditch was still frozen at this time, and that there was no water supply from melting snow. Therefore, the water source that caused thaw weakening issue was major resulted from the melting of frozen soil within the pavement structure.

Secondly, it is important to point out that the mean monthly temperature for May, 2013 was lower than in previous years, so the thawing front only penetrated to 1.22 meters (4 feet) on the east side and 0.76 meters (2.5 feet) on the west side. For the other years monitored, the distance between the thawing front and the 0 °C isothermal curve increased each year. This phenomenon can be explained by referring to the moisture contour during freezing process, as discussed in the previous section. Since the saturation zone in the pavement structure was decreasing during the monitored four years, the total amount of water stored in the pavement structure (including capillary water extracted from shallow groundwater) was also decreasing. Since the specific water capacity was

Thirdly, the highest moisture content areas were all located on the west side of the embankment, but no saturation zone was observed during the thawing process in the monitored four years. This phenomenon proved that the wicking fabric successfully eliminated the frost boiling issues. Moreover, the thawing front on east side of the embankment was deeper than that on west side and reached to the elevations where the two layers of wicking fabrics were buried. This phenomenon indicated that the wicking fabric on east side of the pavement structure was partially functional and started to laterally drain the water out of the pavement structure in late May, 2014, as shown in Figure 5.2(d).

thawing process were also decreasing. As shown in Figure 5.2, there was no saturation zone present in the pavement structure during the thawing process. Additionally, the wicking fabric successfully drained water laterally out of the pavement structure within several hours, even after heavy rainfall events. The moisture contents near the wicking fabric were much higher than moisture contents in other areas, demonstrating that the fabric worked effectively to transport the water out of the embankment. The moisture contents in east (dry) side of the pavement structure reached equilibrium generally within 1 day of significant rainfall events.
