**APPLICATION OF WICKING FABRIC TO REDUCE DAMAGE IN
ALASKAN PAVEMENTS**

Final Project Report

AUTC Project No. xxxxx
Project Title: Application of Wicking Fabric to Reduce Damage in Alaskan Pavements

December 2015

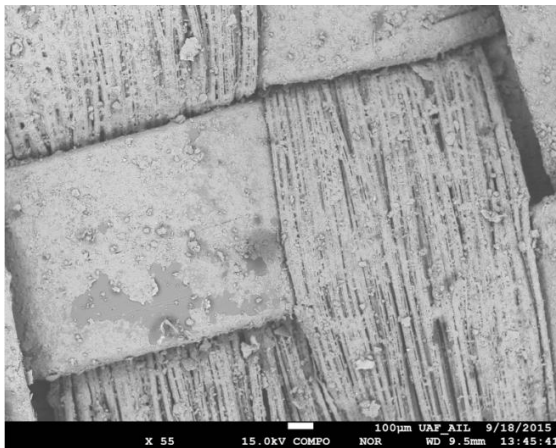
(a) Intact Sample (Sample 4)

Figure 5.3(a) presents the woven structure of a sample at Beaver Slide with $\times 55$ magnification. Large amounts of soil particles were detained on the surface of the wicking fabric. Because the soil contained approximately 6% of fines, the fine materials blocked the deep grooved drainage paths. Figure 5.3(b) shows a closer view of the wicking fabric at the surface with $\times 350$ magnification. It further illustrates the fact that the deep grooved drainage paths were completely filled with fine soil particles. In comparison, Figure 5.3(c) shows the wicking fabric fibers just beneath the surface layer. The deep grooves beneath the surface were much cleaner than those above, and there were very few particles that had been detained in the drainage paths. In other words, the

fibers of the wicking fabric at surface served as a protective layer, preventing the fine soil particles from penetrating deeper into the fabric structure. Figure 5.3(d) shows the comparison of the wicking fibers on the surface and the fibers just beneath the surface. It can be visualized from the figures that even though the wicking fabric fibers on surface were filled with fine soil particles, the wicking fibers beneath the surface still work effectively to laterally drain water out of the pavement structure. It is worth noting that it is not fair to evaluate if the wicking fabric is clogged based upon the fibers on the surface since “surface” is a theoretic term and difficult to define during the SEM analyses. If too many soils are left on the surface of the wicking fabric, there is no doubt that the wicking fabric will be covered by the soils. On the other hand, if we take all the surface soil away, the evaluation for the clogging effect is not objective. It seems more reasonable to evaluate the clogging effect based upon the wicking fibers below the surface. From Figures 5.3(c) and 5.3(d), it is concluded that clogging is not a concern for the wicking fabric.

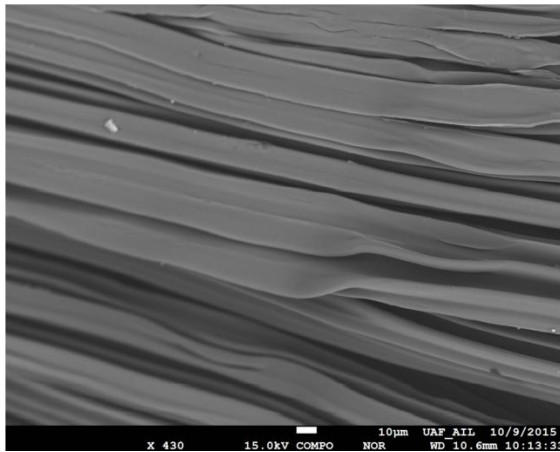
(a) New Wicking Fabric (Intact Sample 4)

Figure 5.4 presents the SEM images of samples that suffered permanent deformation and mechanical failure. Figure 5.4(a) presents images of new wicking fabric, which was brand new. It was apparent that the wicking fabric fibers under the woven polypropylene yarns had already experienced some permanent deformation, and that the deformation was in the vertical direction. The pressure applied in manufacturing process may have caused this deformation, or it may have occurred during the transportation process. Figure 5.4(b) shows SEM images of the wicking fabric that was collected from the field. The permanent deformation observed in the new materials had further increased. Due to additional vertical pressure, the wicking fabric fibers were nearly flattened, and the deep grooves were not able to hold water under unsaturated conditions. Furthermore, Figure 5.4(c) presents the front view of the wicking fabric; deep grooves are seen not only in the vertical direction, but deep grooves also tended to close in the horizontal direction.

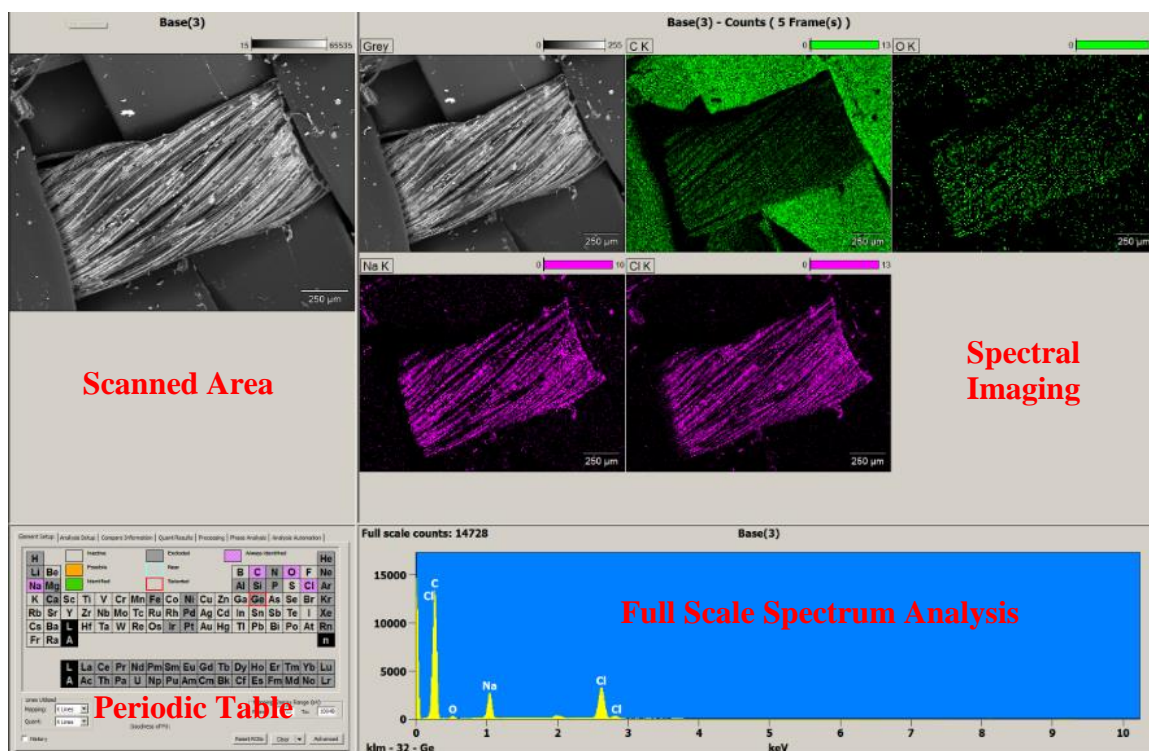
Figure 5.6 Salt Concentration Test Result Demonstration

NaCl solutes were made with different concentrations, including 10 g/L, 20 g/L, 30 g/L, 40 g/L and 50 g/L. Two types of samples were prepared, namely air-dried samples and rewetted samples. The air-dried samples are prepared by air-dried the wicking fabric that be dipped into the aimed salt solution. The rewetted samples were prepared by washing the air-dried samples with water and then air-drying them. Figure 5.6 demonstrates the spectral scanning results. The scanning area shows part of the wicking fabric that was scanned and analyzed. The full-scale spectrum analysis gives the raw scanning data, which indicates the total number counts for each chemical element preselected in the periodic table. Based on the selected chemical elements from the periodic table, the spectral imaging shows the concentration of the scanning area. Since the wicking fabric is made of polypropylene yarns, the carbon element was identified as the representation of the wicking fabric. Meanwhile, the soluble salt used in the salt concentration test is sodium chloride (NaCl), both Na^+ and Cl^- ions are considered as the representation of the severity of concentration. In general, the brighter shown in the carbon element spectral imaging, the less salt concentration it represents. In contrast, the brighter shown in the sodium and chloride elements, the more salt concentration shall be expected.

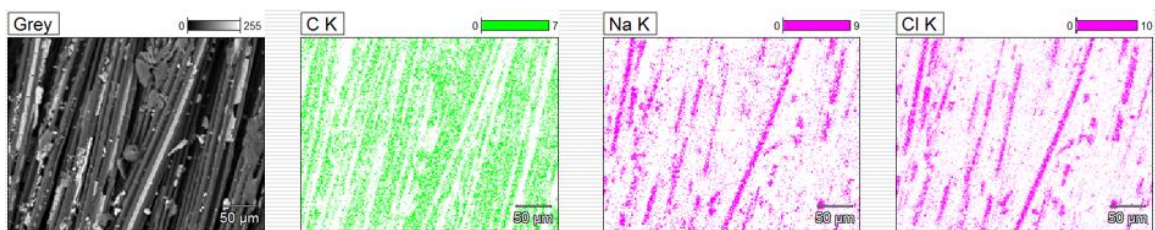
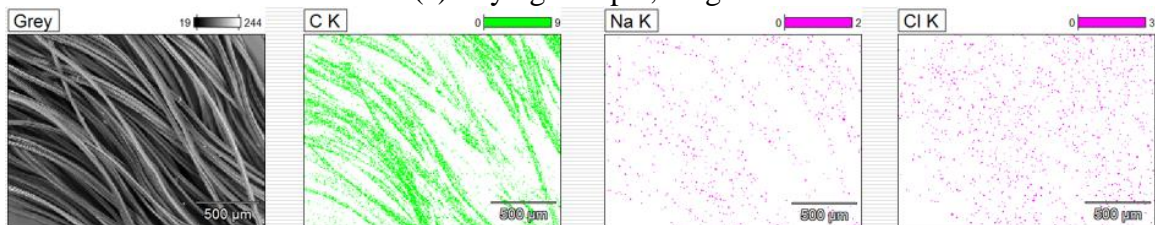
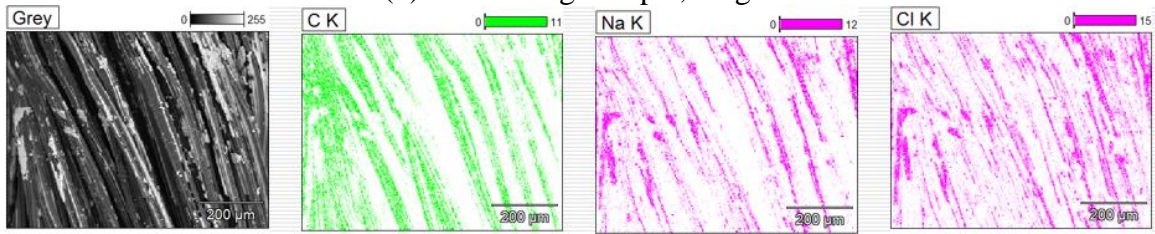
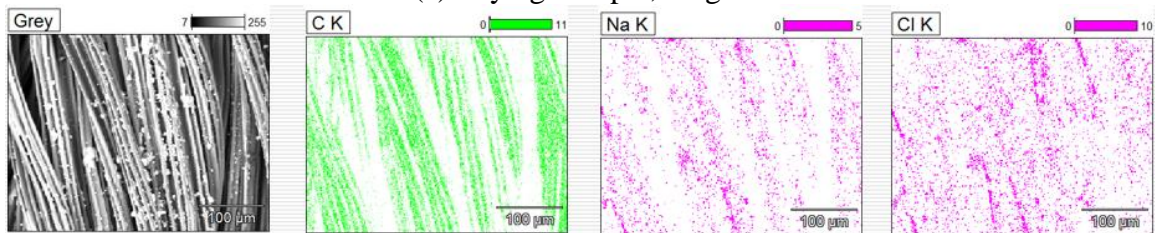
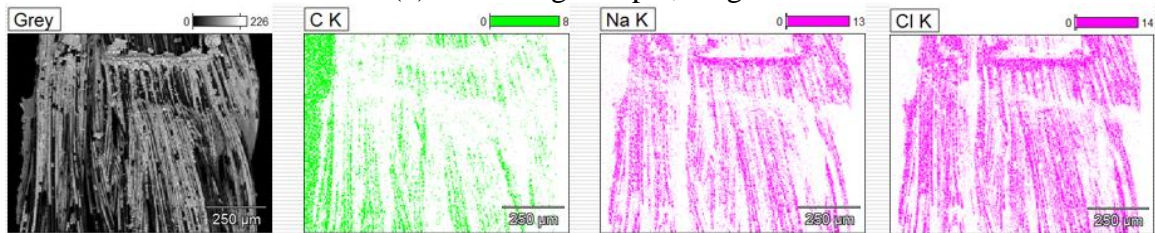
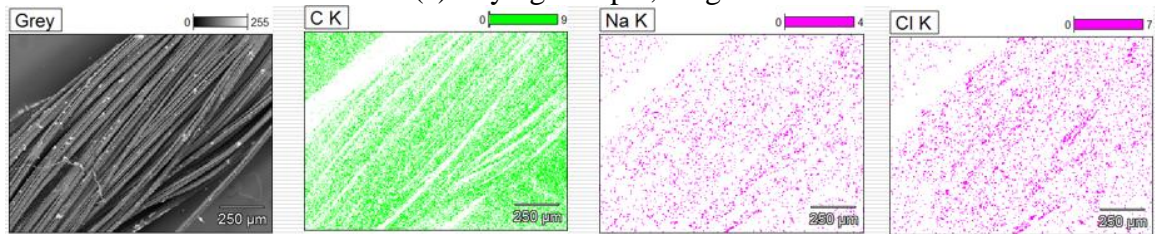
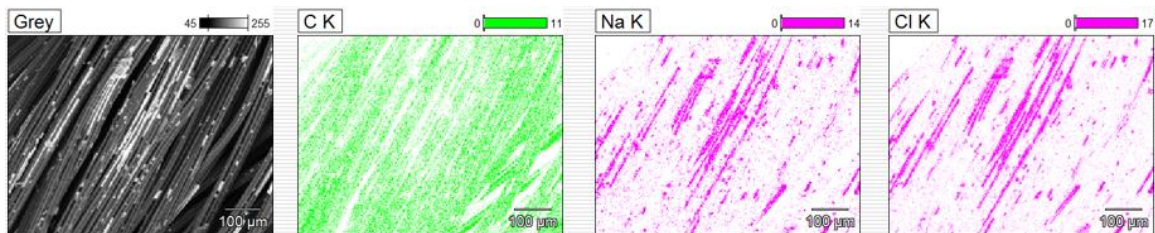
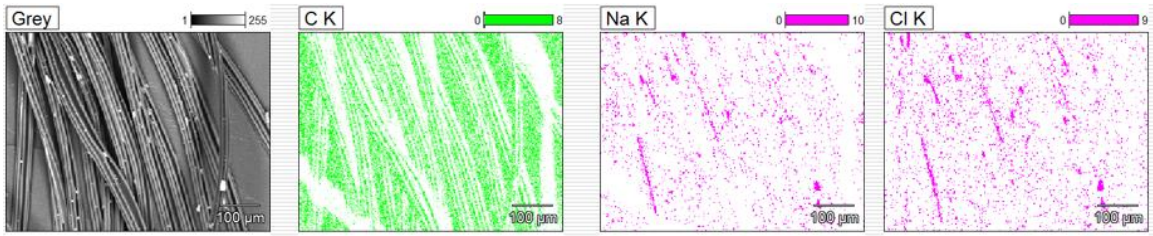
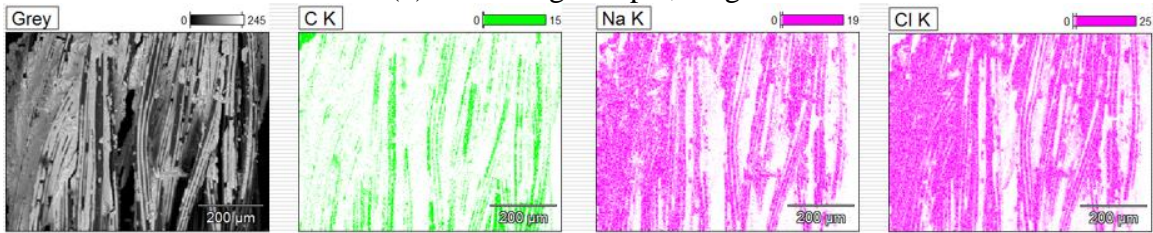
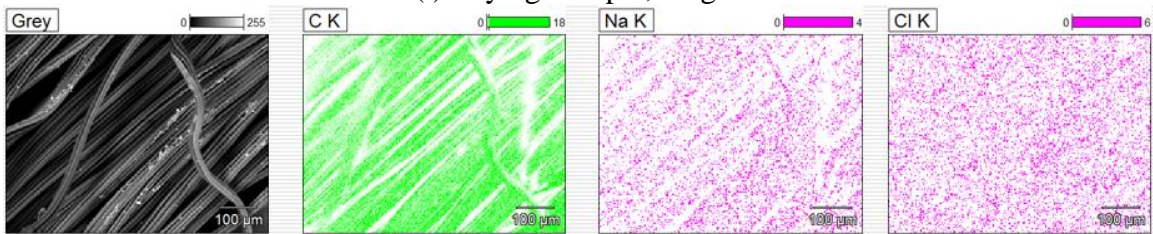
Figure 5.7 Salt Concentration Test Results**Table 5.2 Salt Concentration Test Result Summary**

Figure 5.7 shows the salt concentration test results for both air dried and rewetted samples. Since wicking fabric yarns represents better the severity of salt concentration, the selected scanning area only included the hygroscopic nylon yarns rather than the polypropylene yarns. It is reasonable to expect that the salt detained on the deep grooves of the wicking fabric will increase with the increment of salt concentration in solute. The bar at top of each figure shows the severity level of salt concentration. The test results showed that the average concentration levels for drying samples were 10, 13.5, 13.5, 15.5 and 22 for salt solute with concentrations of 10 g/L, 20 g/L, 30 g/L, 40 g/L and 50 g/L, respectively. The bright strip shape of sodium and chloride spectrum images indicated that concentration areas mostly occurred in the deep grooves of the nylon yarns. For comparison, the severity of salt concentration for rewetting samples were approximately within the same magnitude, only slightly increased from 2.5 to 9.5 when salt concentration of solute increased from 10 g/L to 50 g/L. Since the salt used in the test was sodium chloride, which is a common type of soluble salt, it is reasonable to expect that most of the salt concentrated on the wicking fabrics would be washed away during the rewetting process. Table 5.2 summarizes the test results for salt concentration test results. In sum, even though salt concentrated in the deep grooves in the wicking fabric yarns during the drying process, the salt would be washed away due to the solubility of the salt used in the test.
